# Seismic Performance of Steel Pipe Pile to Cap Beam Moment Resisting Connections

## Final Report

North Carolina State University  
Raleigh, North Carolina

January 2013

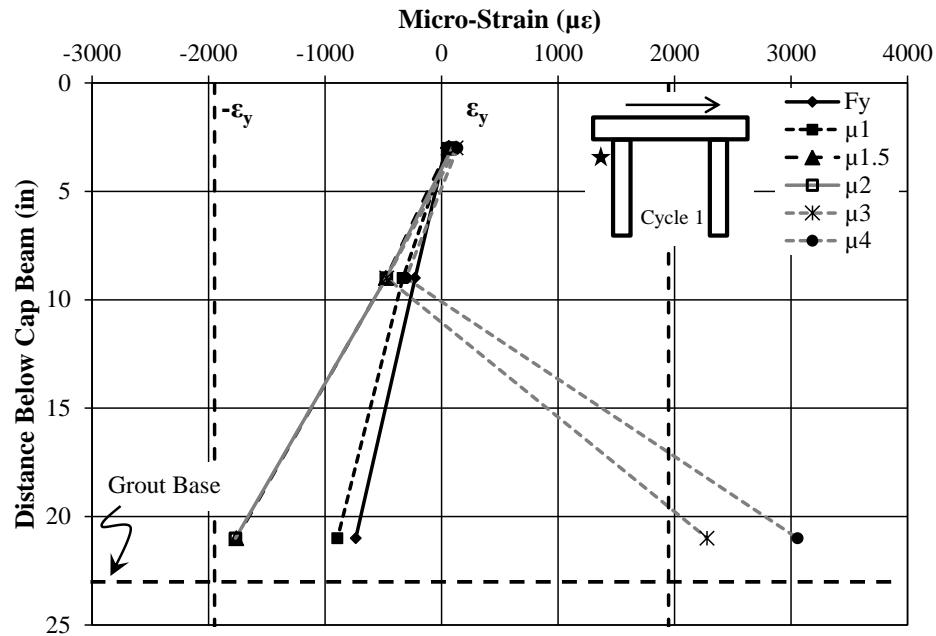
**Figure 6.193 Test 6 – North Column North Face Connection Strain Elevation**

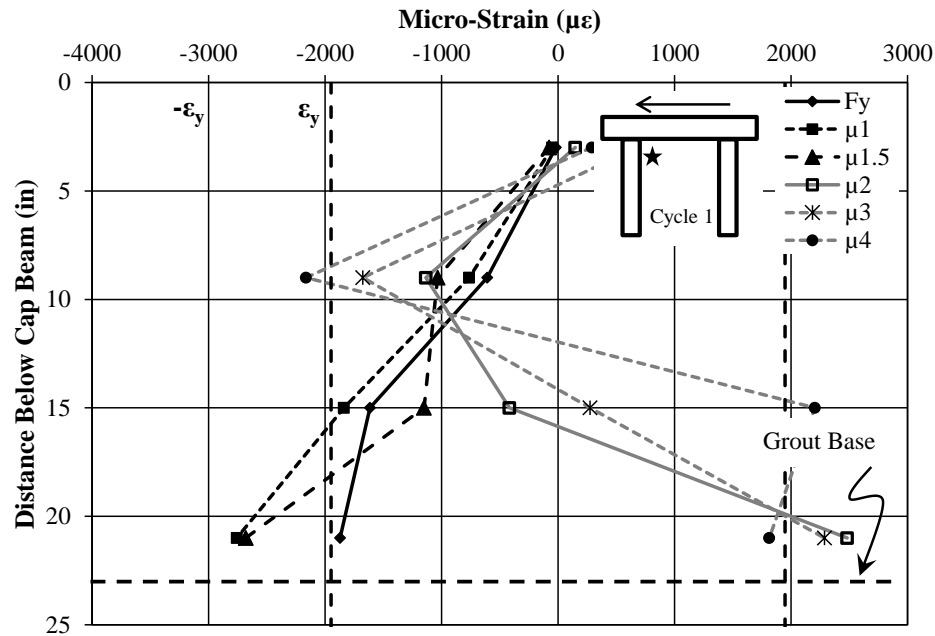
**Figure 6.196 Test 6 – North Column South Face Connection Strain Elevation**

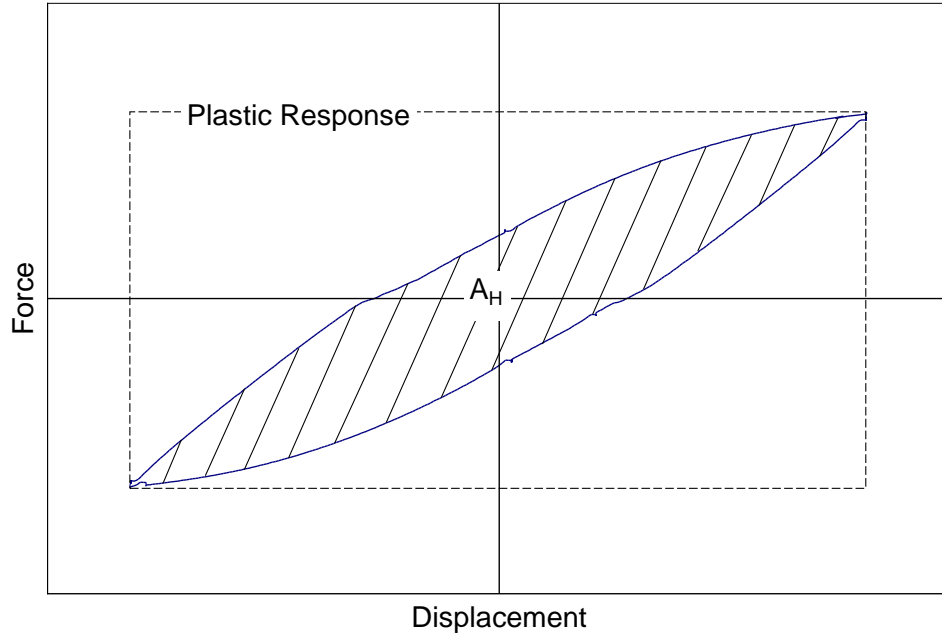
**Figure 6.202 Jacobsen's Equivalent Viscous Damping Approach**

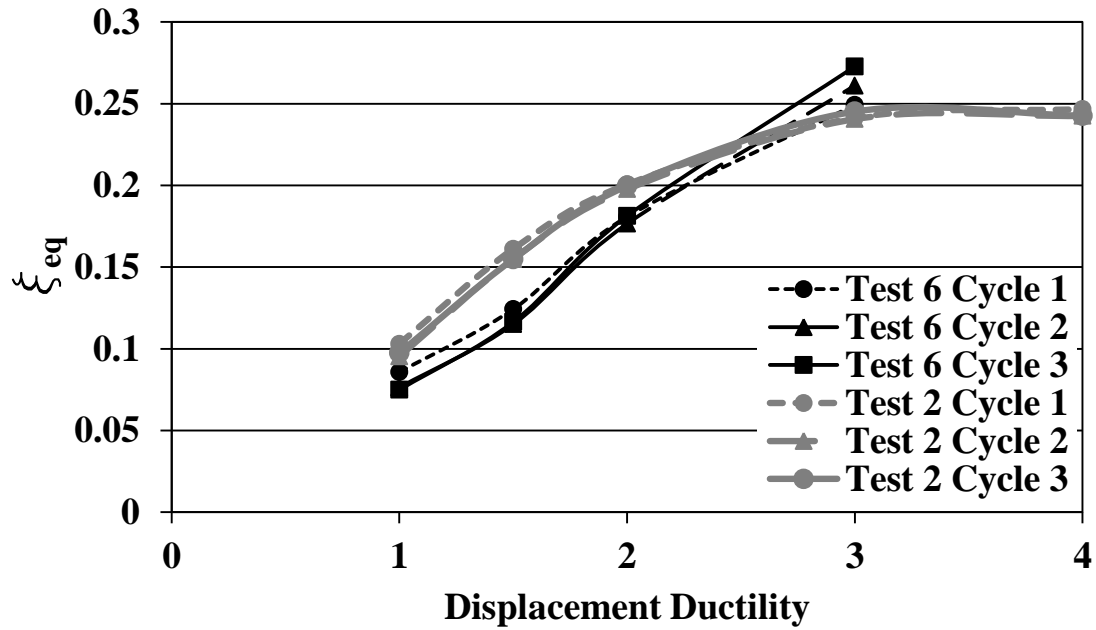
Figure 6.203 Total EVD Test 6 vs. Test 2

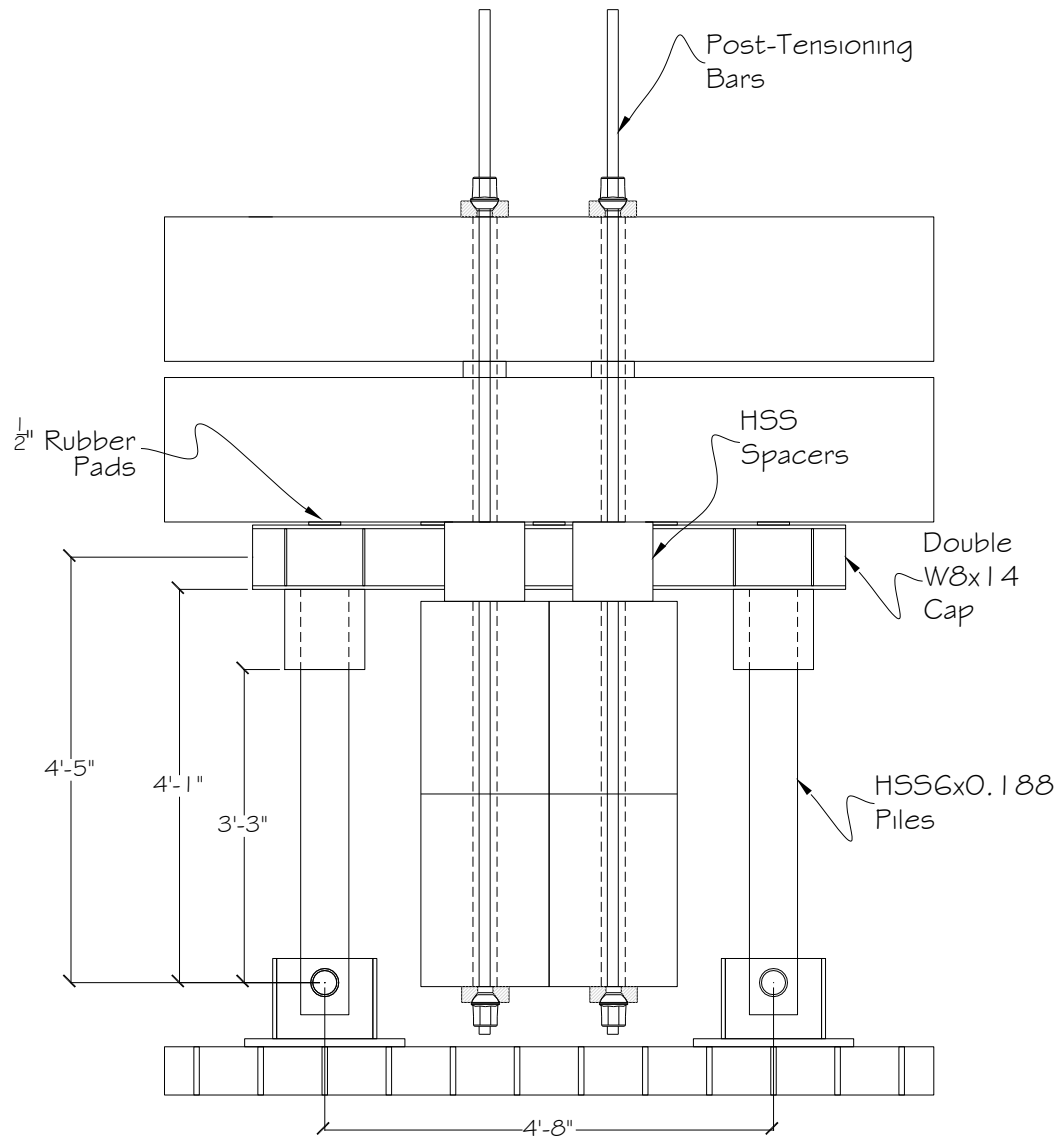
**Figure 6.207 Scaled G.S.C. Steel Pier NS Elevation (Phase 2 Tests 8 & 9)**

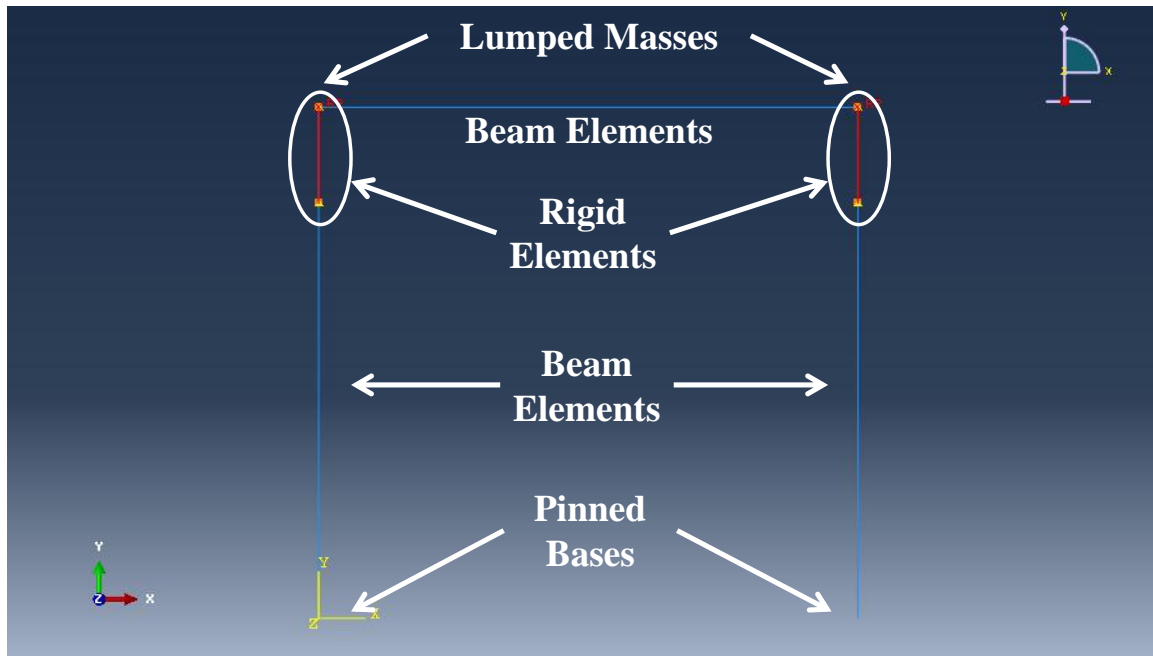
**Figure 6.217 Dynamic Line Element Model Schematic**

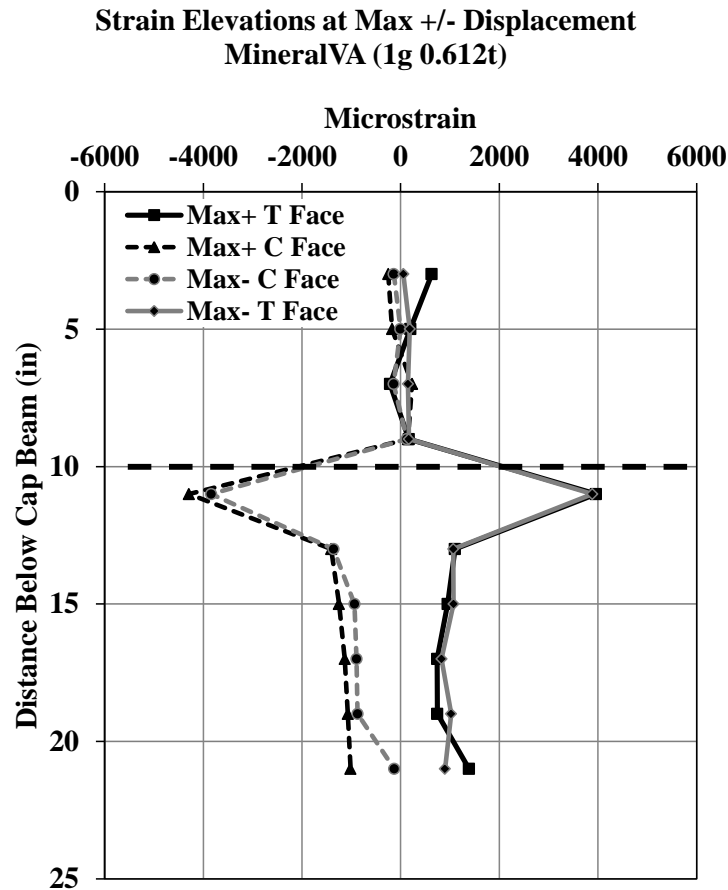
**Figure 6.249 Shake Table Test 1 – Mineral VA Strain Elevations at Peak Disp.**

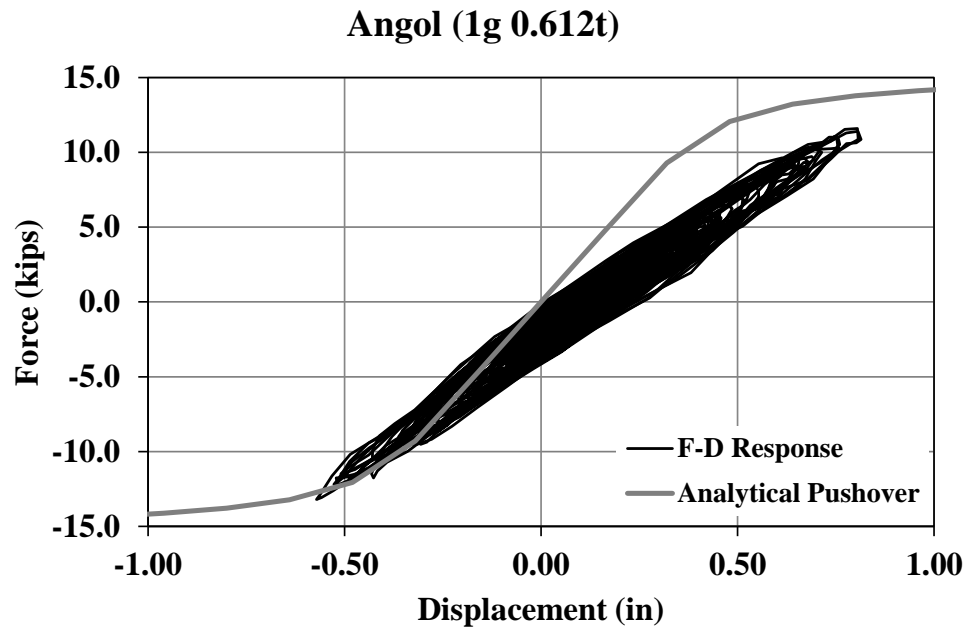
Figure 6.260 Shake Table Test 1 – Angol Force – Displacement Response

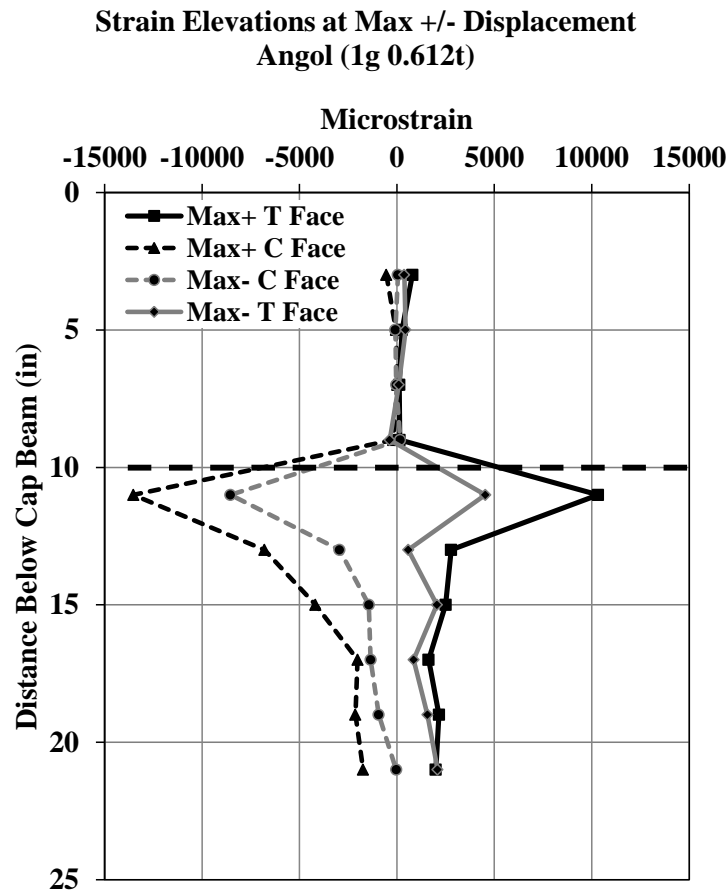
**Figure 6.261 Shake Table Test 1 – Angol Strain Elevations at Peak Displacements**

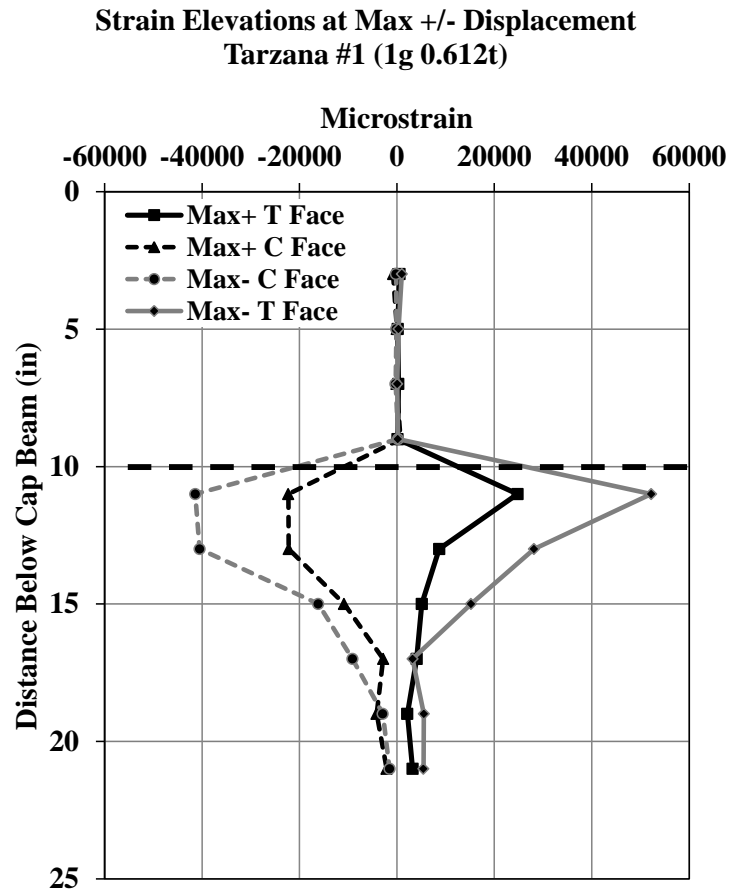
**Figure 6.270** Shake Table Test 1 – Tarzana #1 Strain Elevations at Peak Displacements

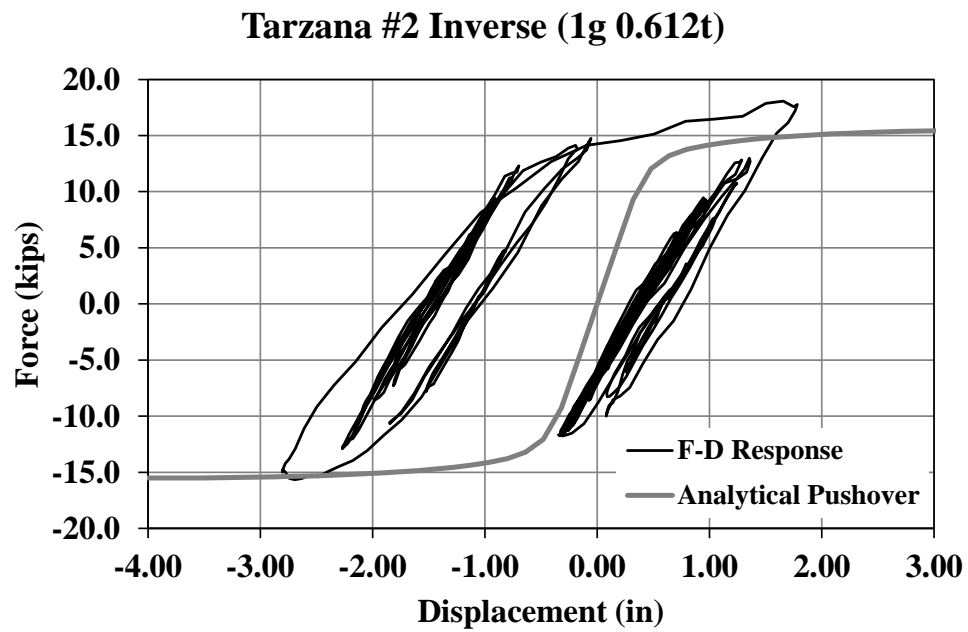
Figure 6.275 Shake Table Test 1 – Tarzana #2 Inverse Force – Displacement Response

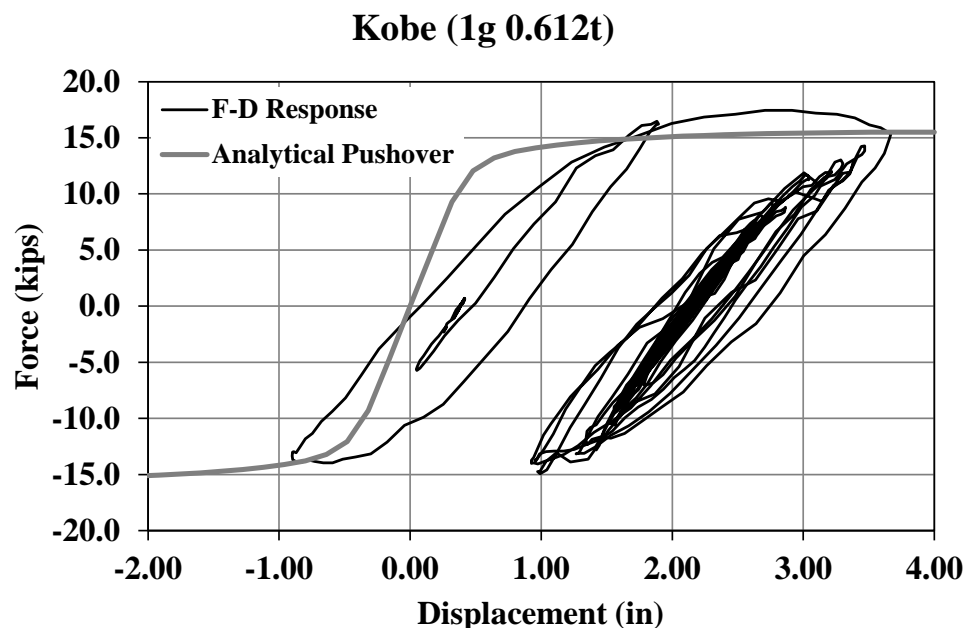
**Figure 6.279 Shake Table Test 1 – Kobe Force – Displacement Response**

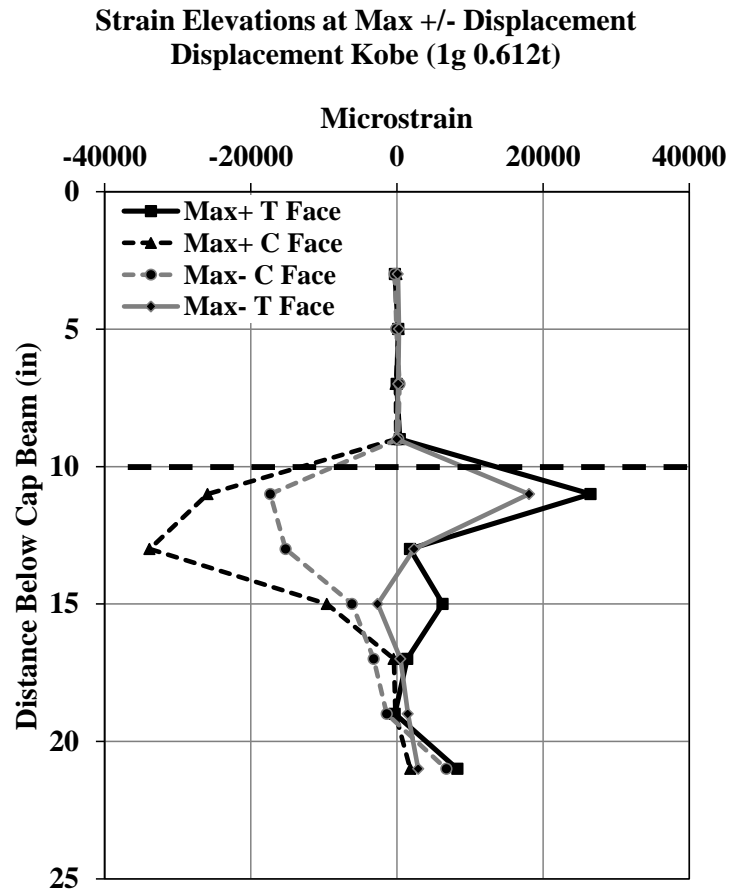
**Figure 6.280 Shake Table Test 1 – Kobe Strain Elevations at Peak Displacements**

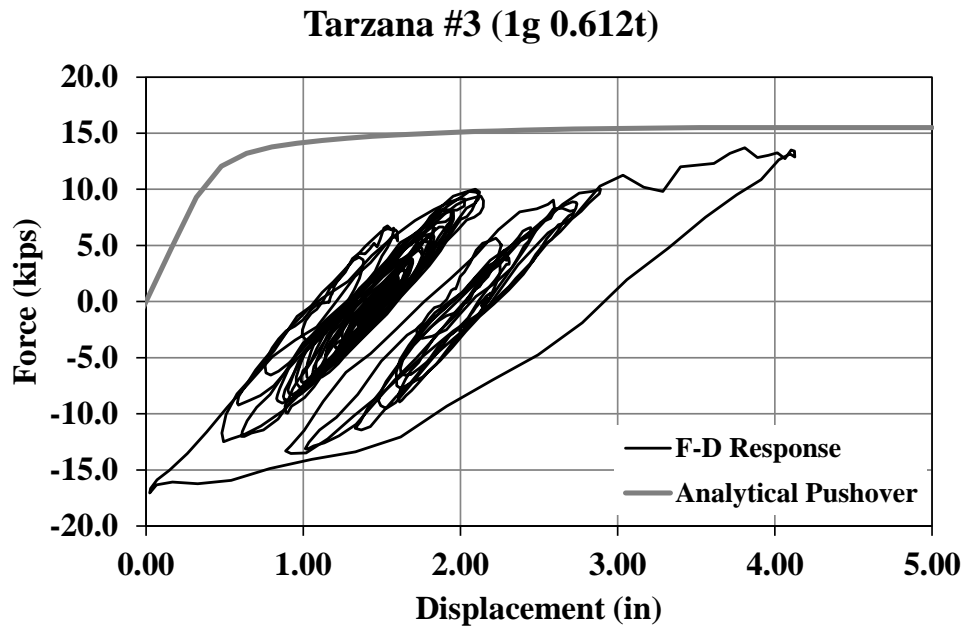
**Figure 6.283 Shake Table Test 1 – Tarzana #3 Force – Displacement Response**

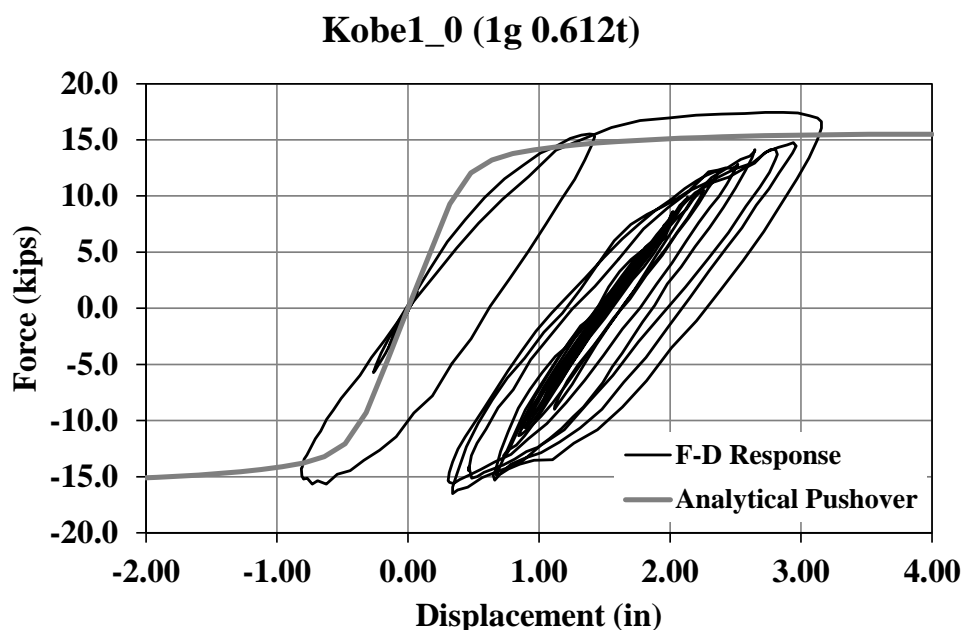
**Figure 6.290 Shake Table Test 2 – Kobe #1 Force – Displacement Response**

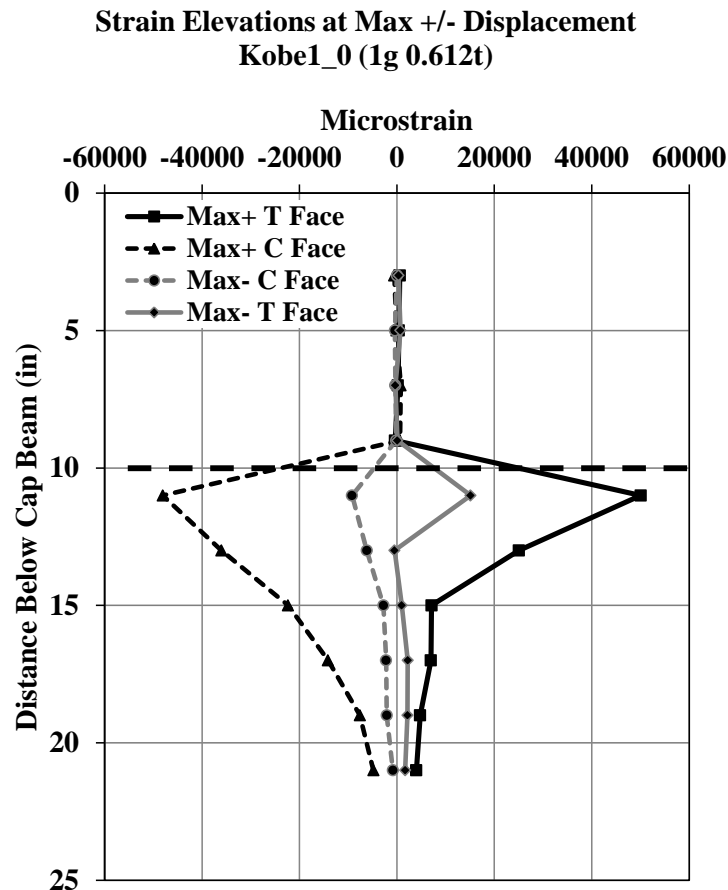
**Figure 6.291 Shake Table Test 2 – Kobe #1 Strain Elevations at Peak Displacements**

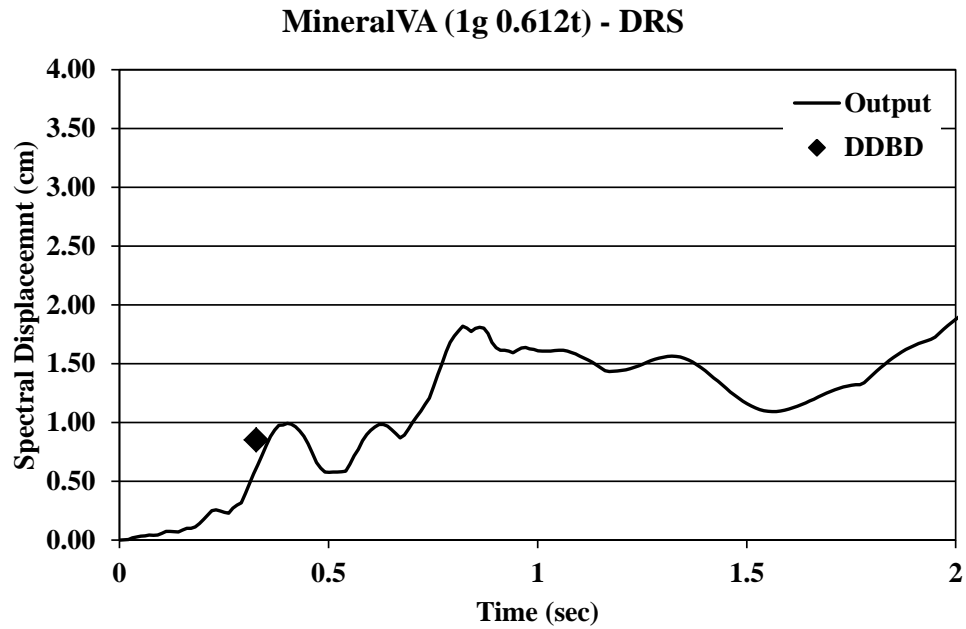
**Figure 6.308 Shake Table Test 1 – Mineral VA – Inverse DDBD Results ( $\xi=5\%$ )**

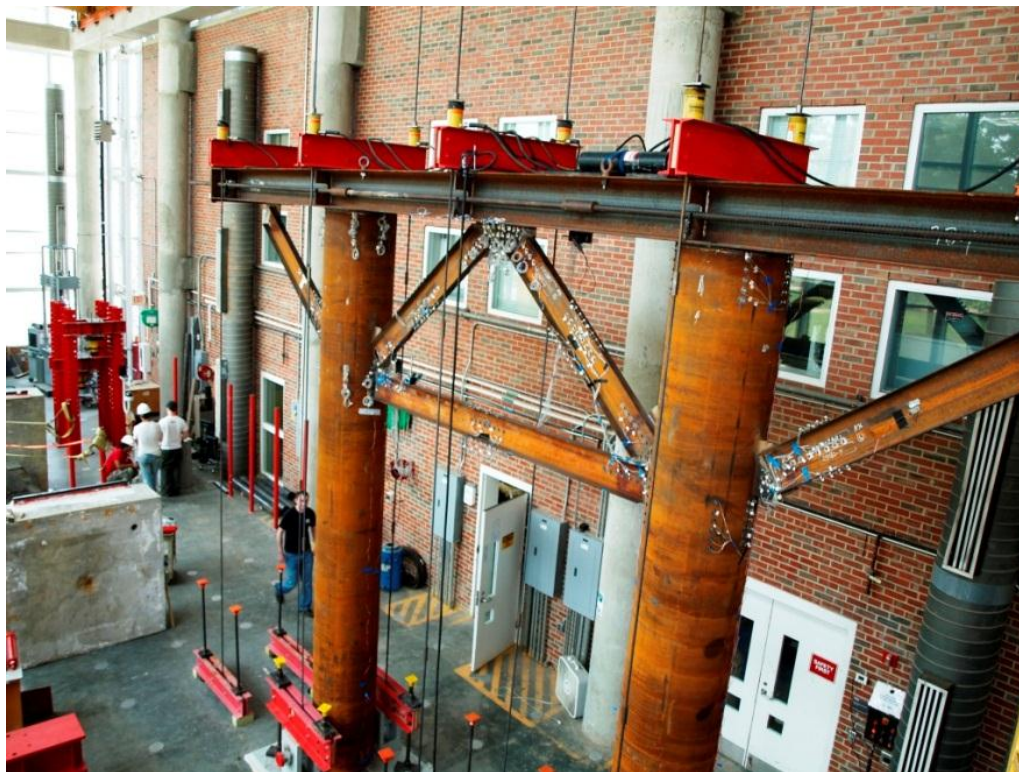
**Figure 7.1. Truss Style Steel Pier Specimen**

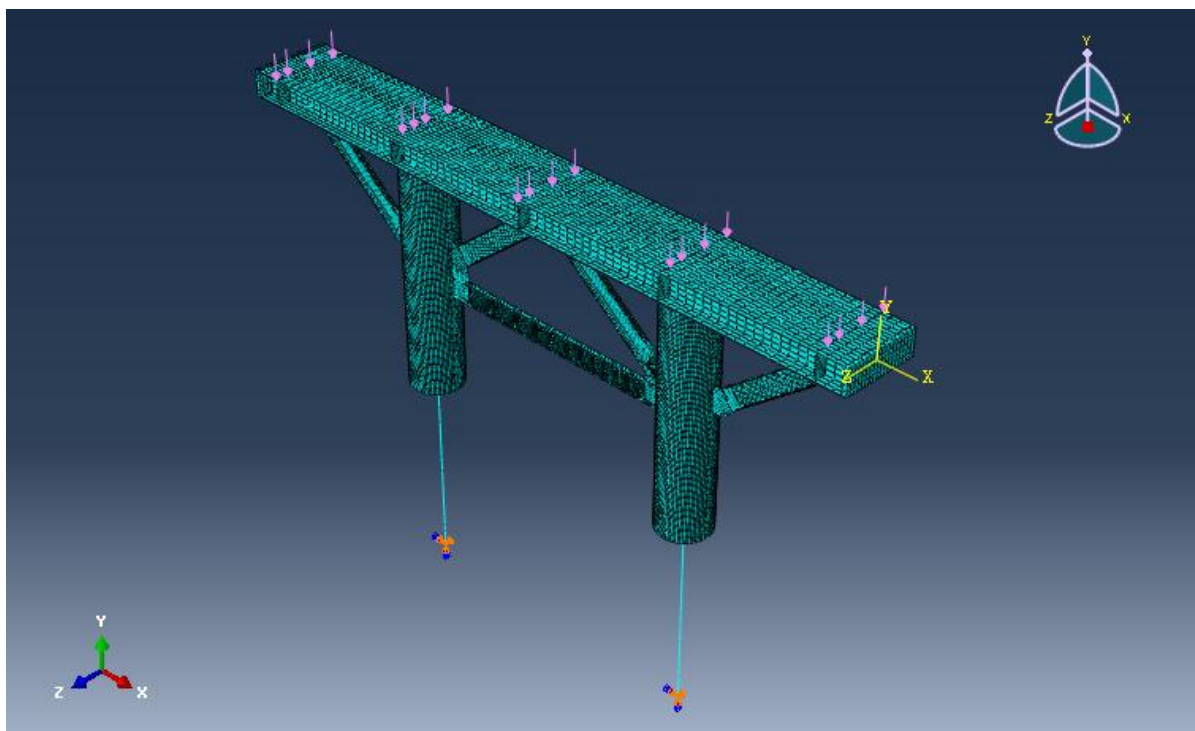
**Figure 7.6 Truss Pier Three Dimensional FEM with Vertical Dead Loads**

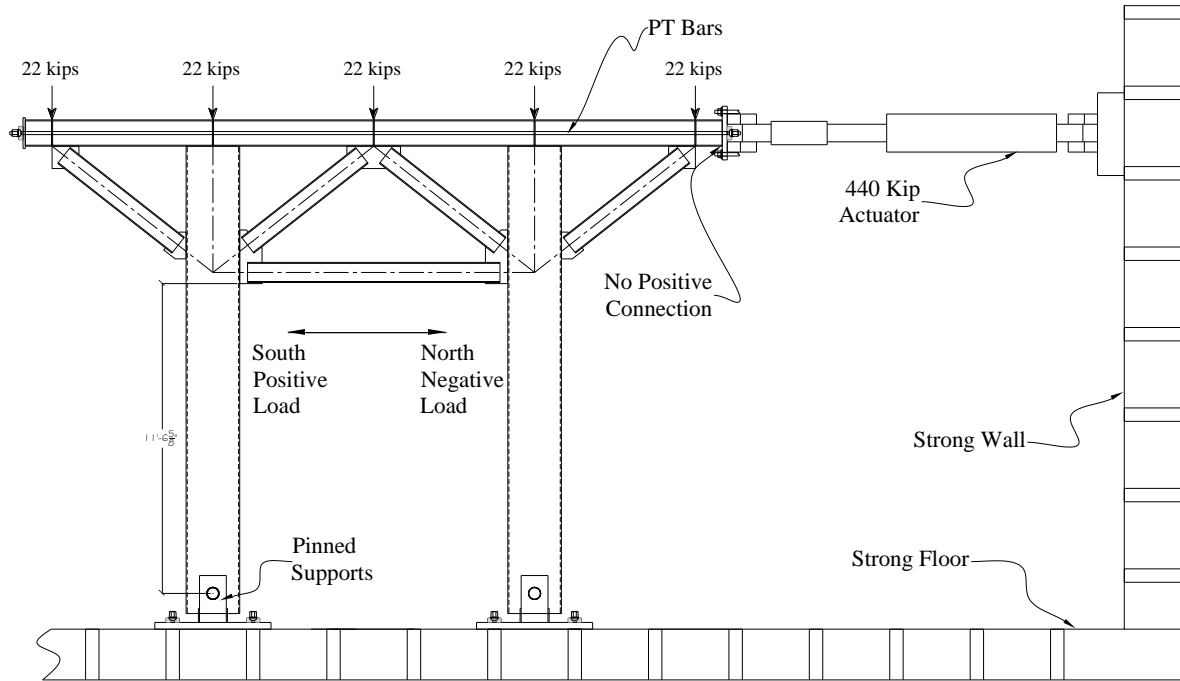
**Figure 7.7 Truss Pier Laboratory Experimental Set Up**

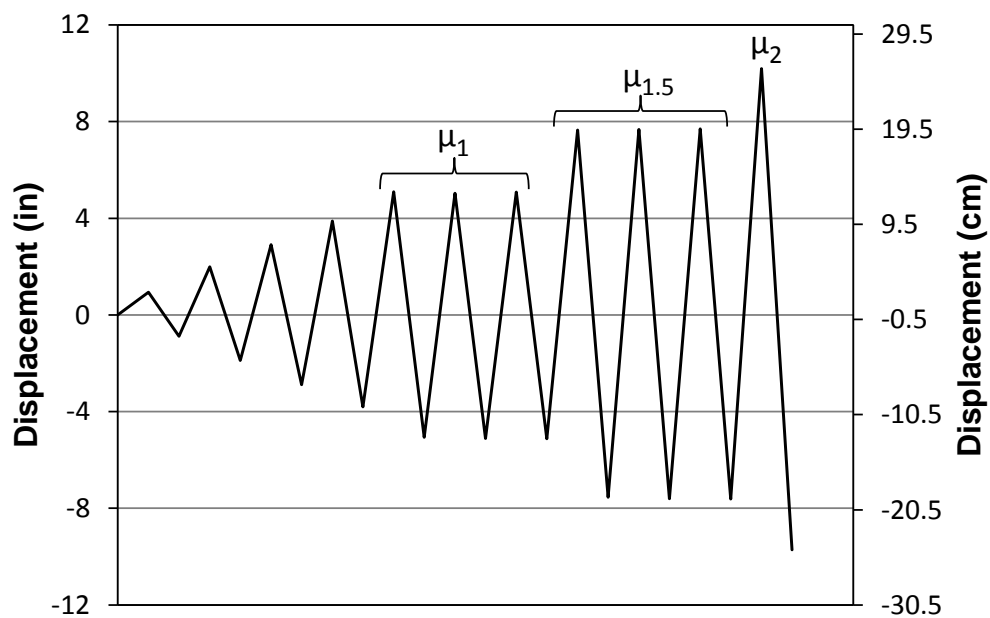
Figure 7.14 Truss Pier – Experimental Displacement History

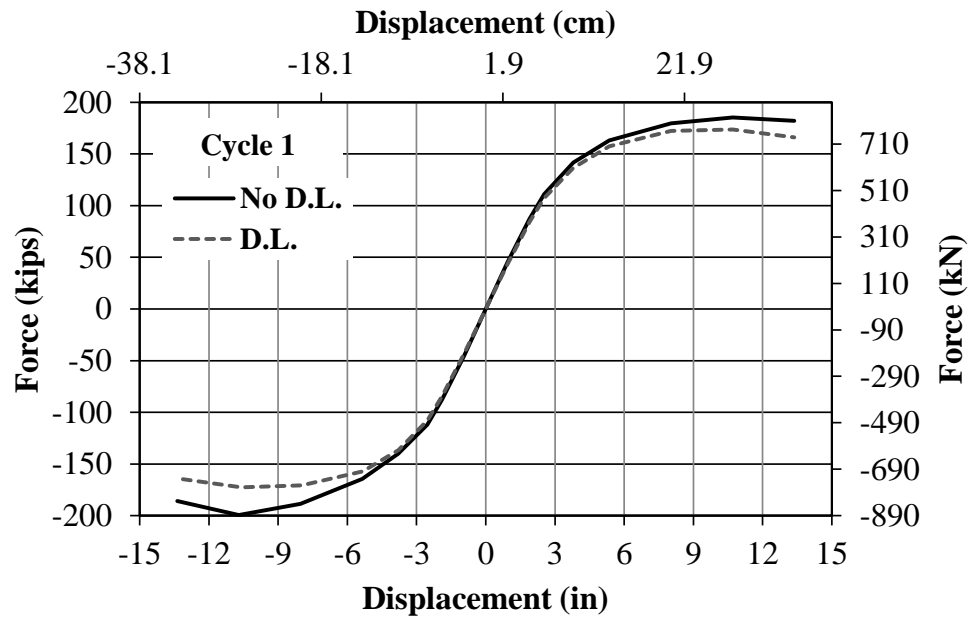
Figure 7.17. Force-Displacement Envelopes No D.L vs. D.L. FEA – Cycle 1

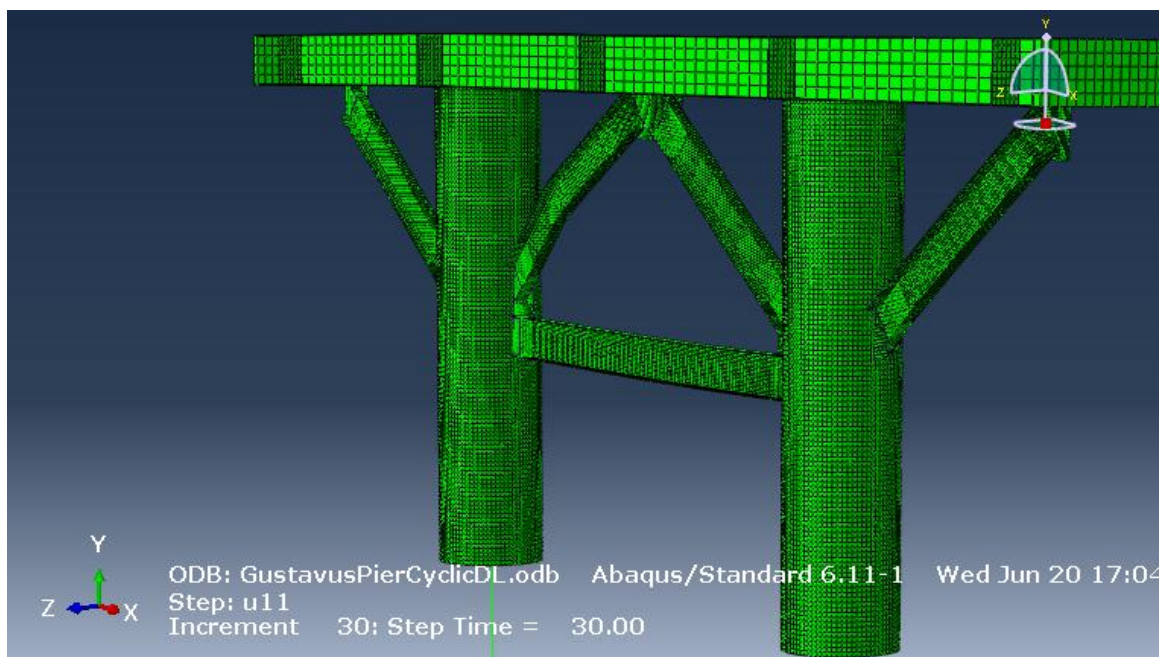
**Figure 7.25. FEA - Ductility 1 Cycle 1 (Def. S.F. = 1.0) – Formation of Brace Hinge**

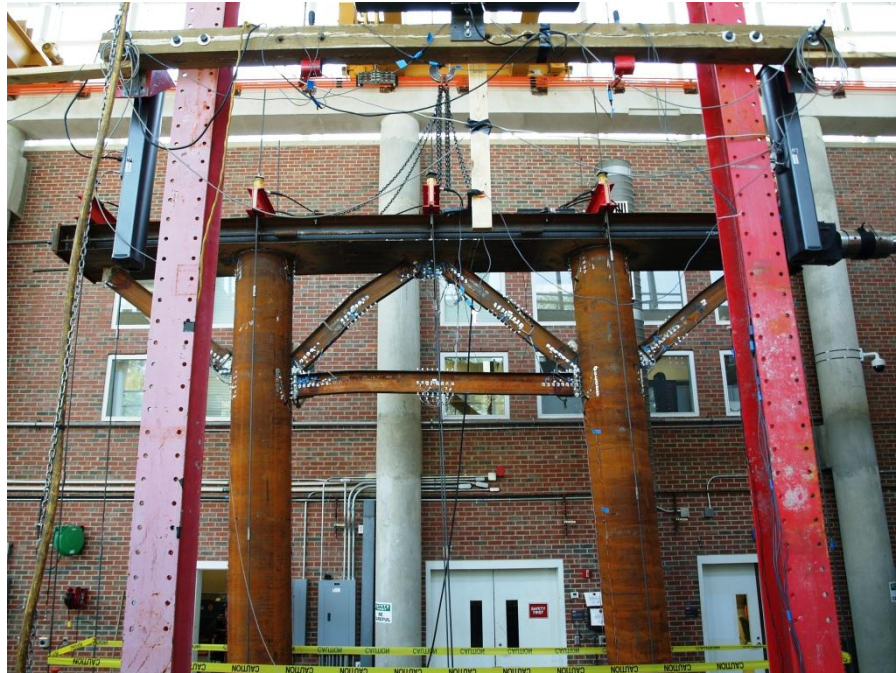
**Figure 7.32 Truss Pier – Ductility 1.5, Cycle 1, 7.62” Displacement, 151 kips**

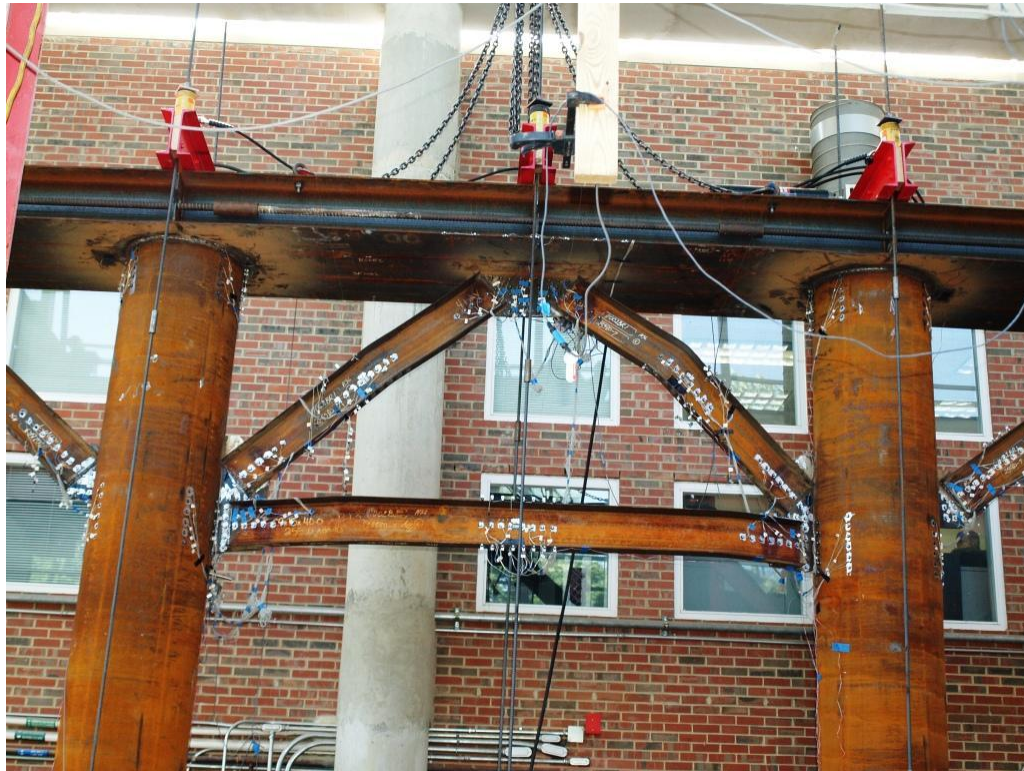
**Figure 7.55 Residual Damage at Conclusion of Test**

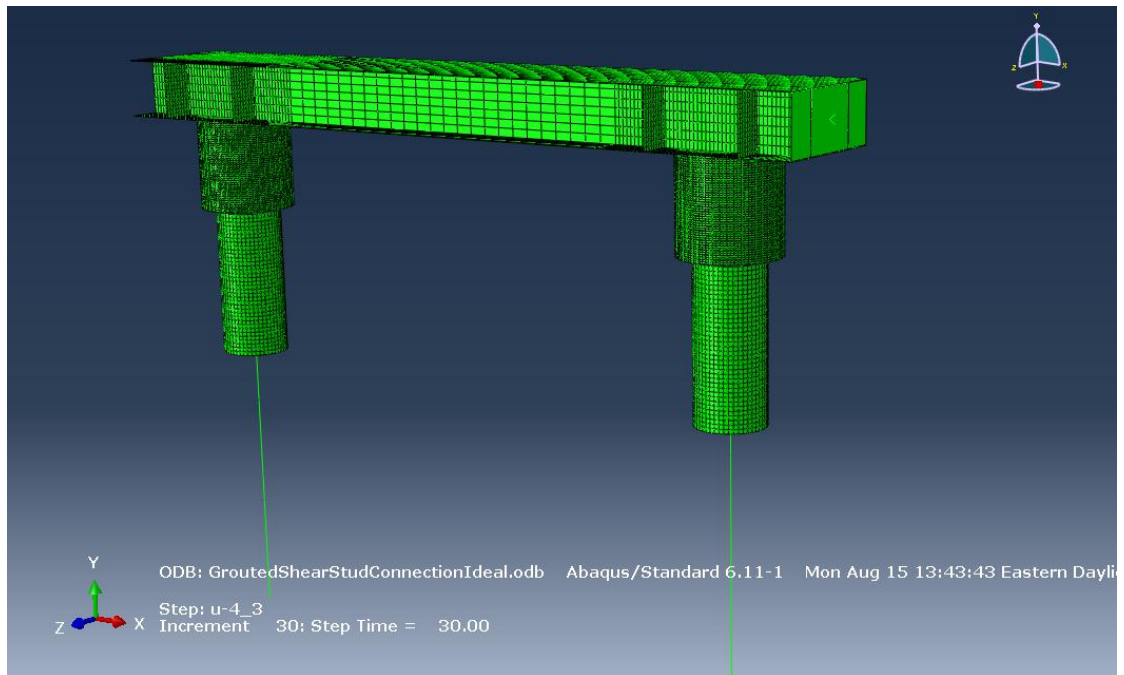
**Figure 8.13 Parametric Study Finite Element Model**

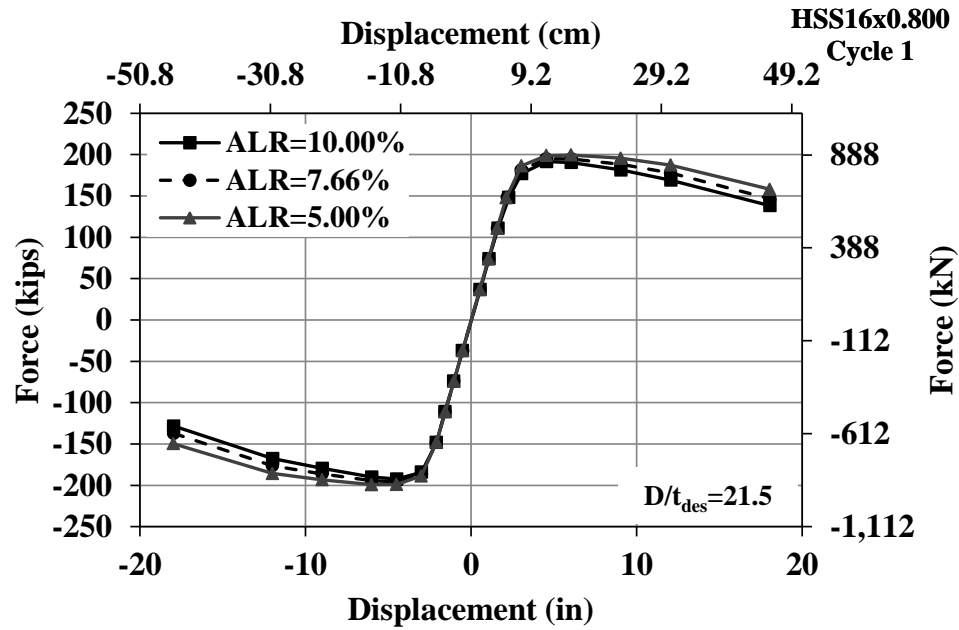
Figure 8.14 Cycle 1 Comparison – HSS16x0.800  $D/t_{des}=21.5$

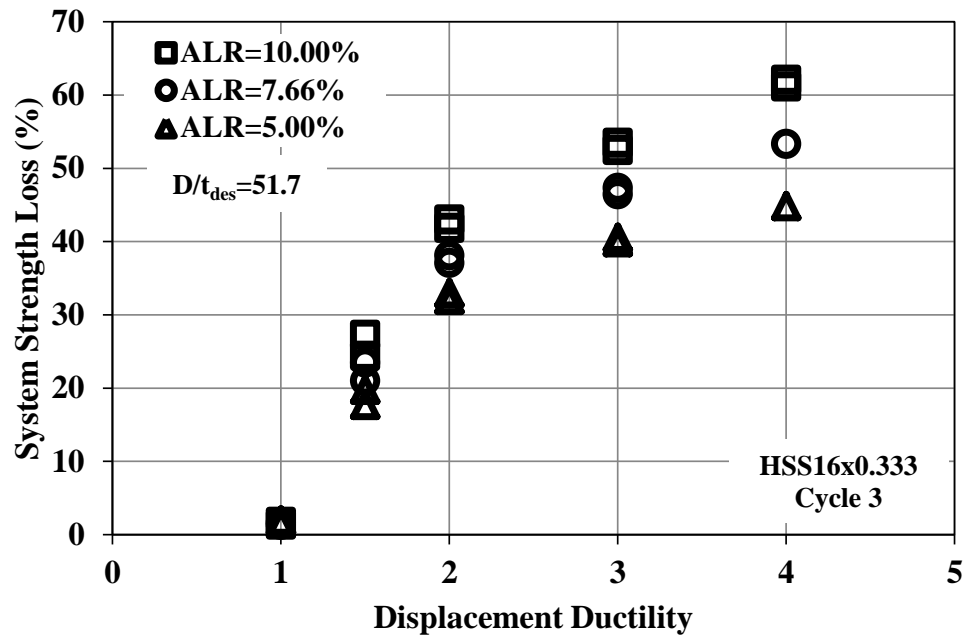
Figure 8.43 Cycle 3 Strength Loss Comparison – HSS16x0.333  $D/t_{des}=51.7$

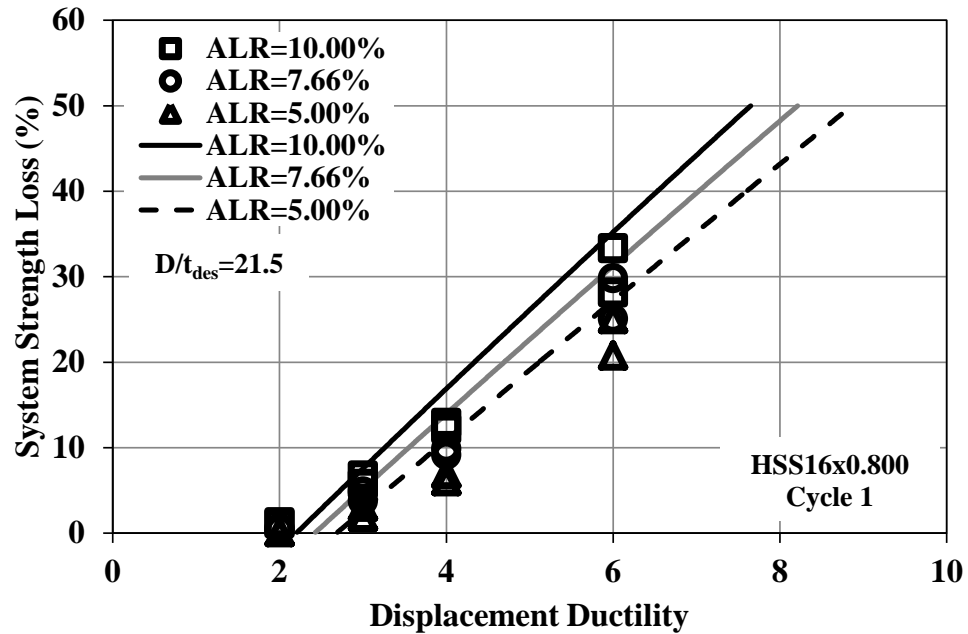
Figure 8.49 SECOND Degree Regression Analysis Results –  $D/t_{des}=21.5$

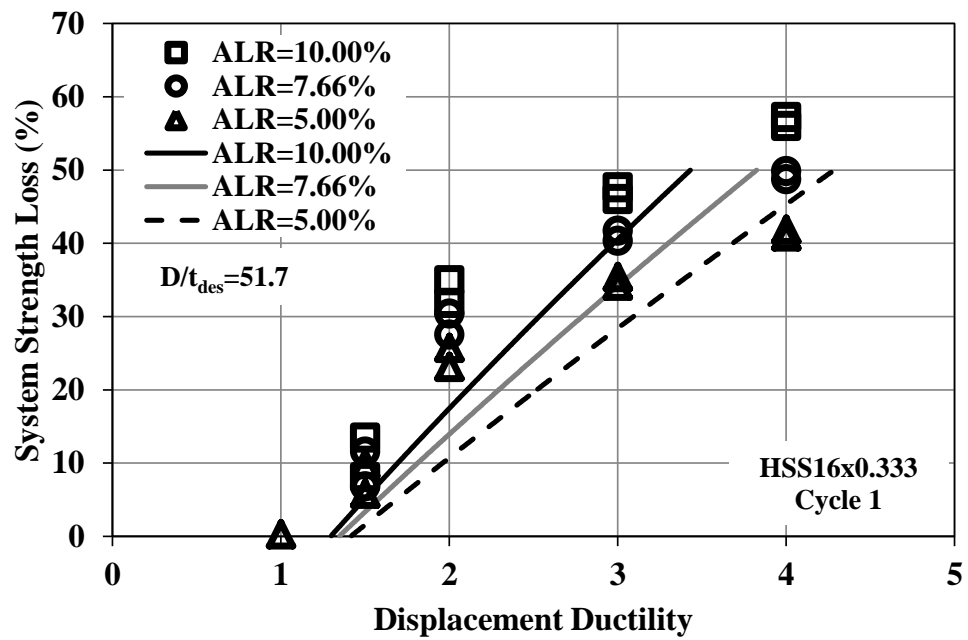
Figure 8.53 SECOND Degree Regression Analysis Results –  $D/t_{des}=51.7$

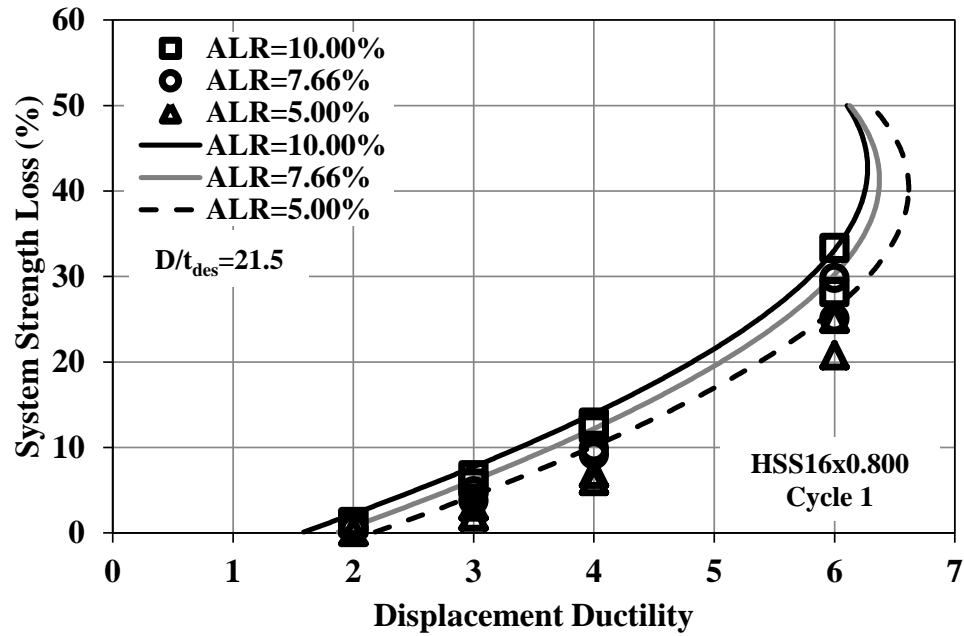
Figure 8.54 THIRD Degree Regression Analysis Results –  $D/t_{des}=21.5$

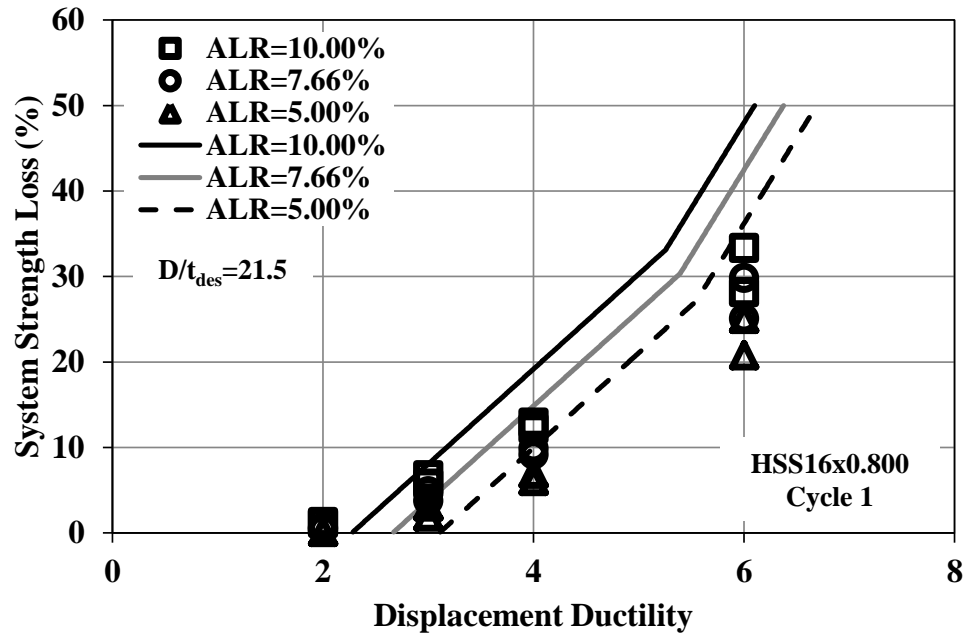
Figure 8.64 Multi-Linear Regression Analysis Results – Cycle 1 –  $D/t_{des}=21.5$

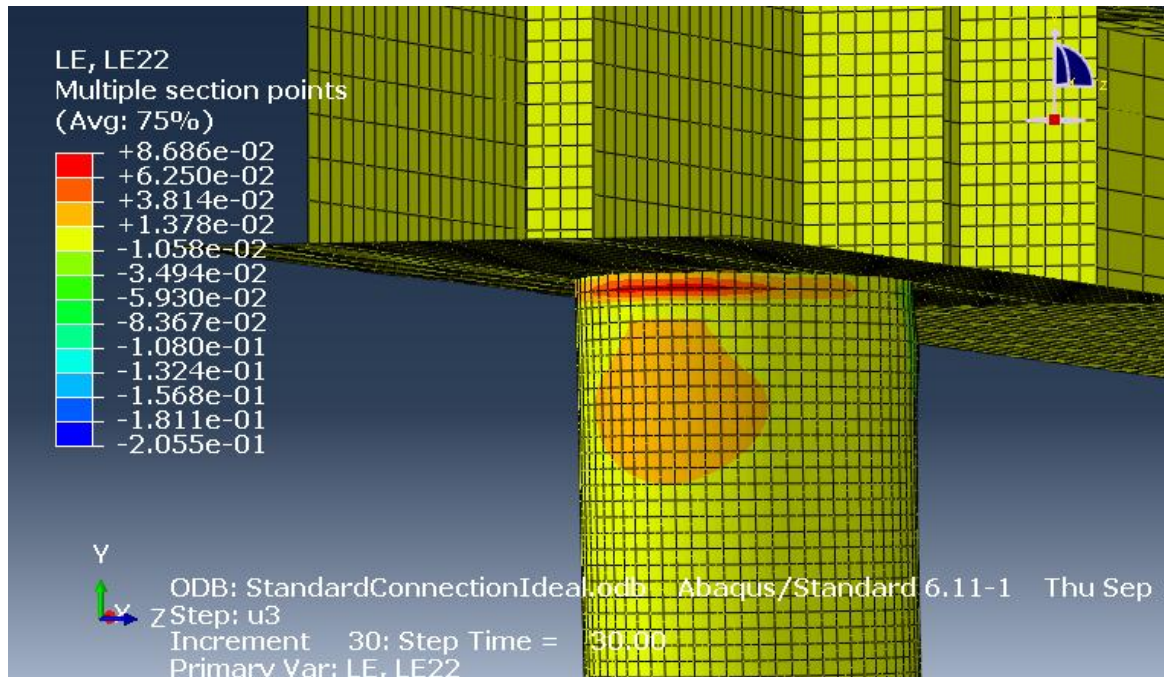
**Figure 9.1 FEM – Local Tension Strain Concentration at Weld Toe Region**
